**INDOOR ATHLETICS  
FACILITY ASSESSMENT  
PRESENTATION**

**BOARD WORKSHOP**  
01.28.2022

LANCASTER COUNTY SCHOOL DISTRICT  
INDOOR ATHLETIC FACILITY ASSESSMENTS  
DRAFT FOR REVIEW: JANUARY 2022

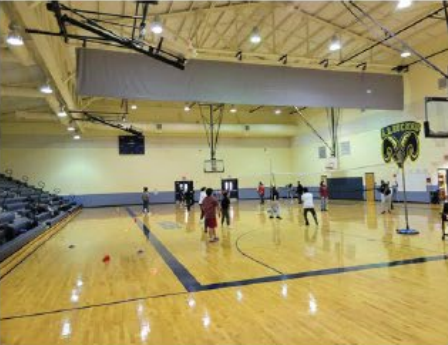
GYM

There are several tears shown in the insulation of the ceiling in the gym which need to be repaired. The gym lighting also needs to be update to LED lighting and the current bleachers do not accommodate accessible seating.

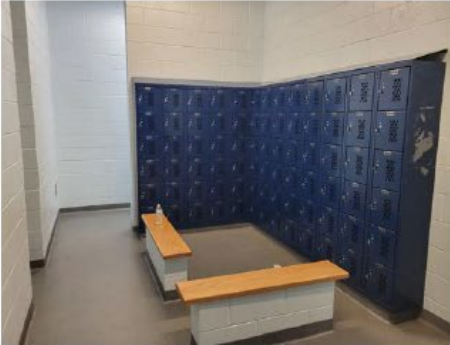
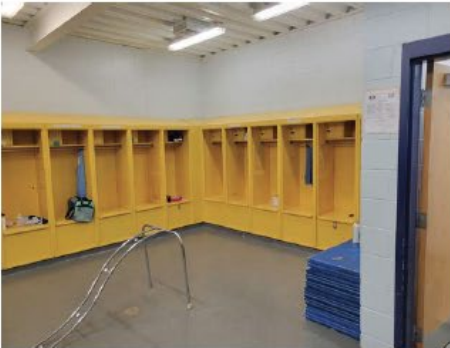
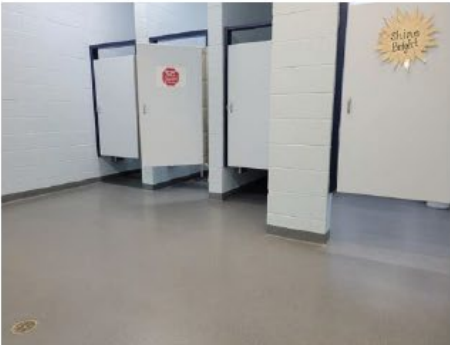
LOCKER ROOMS

The locker rooms and restrooms have resinous floor and CMU walls which both appear to be in good condition. Lockers show minimal wear and tear and most of the plumbing fixtures are in good condition.

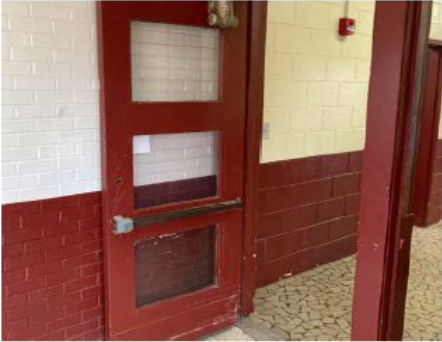
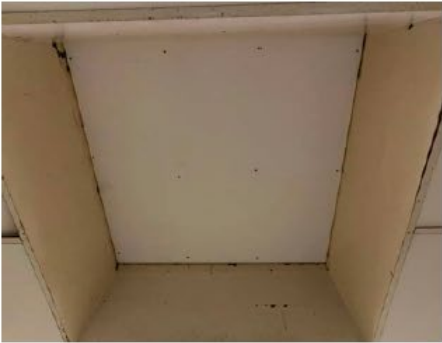
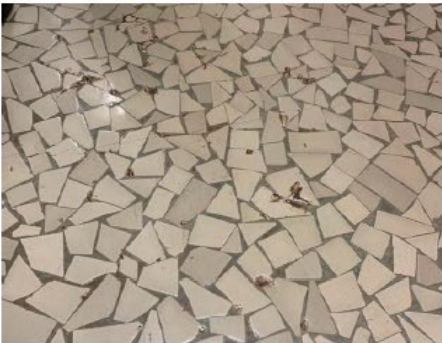
CORRIDOR

Doors and frames show excessive wear and will need to be replaced along with updating the handles to be ADA compliant. The terrazzo floors in the corridor appear to be in good condition, but the lay-in tile for the ceiling will need to be replaced.

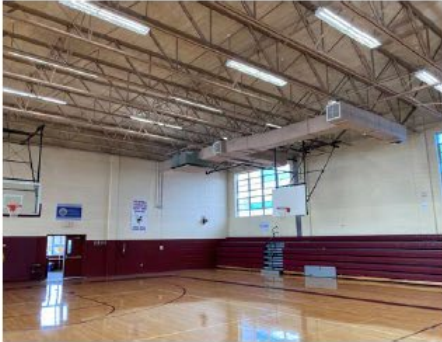
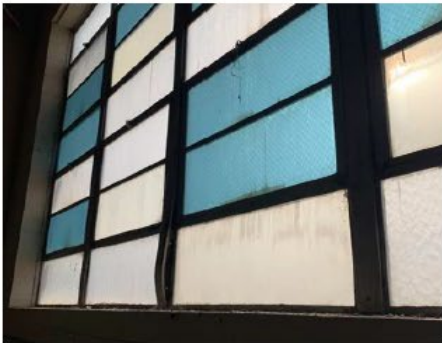
GYM

The gym recently received new hollow metal doors with hollow metal frames, but all windows in the gym need to be replaced with a new fritted glazing. The bleachers are in good condition and are ADA compliant. The basketball goals in the space are in dated and need to be replaced.

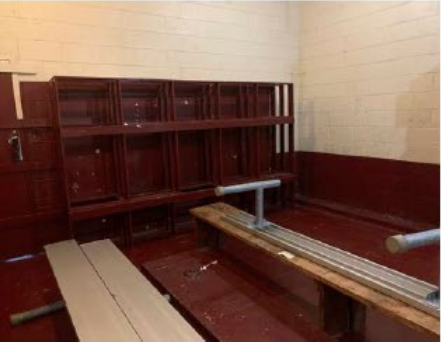
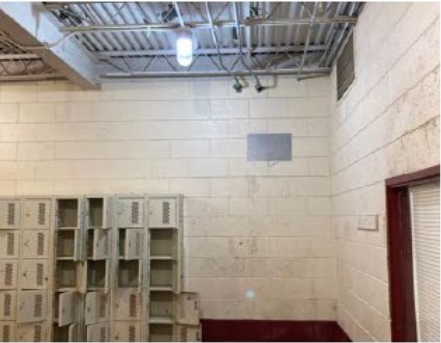
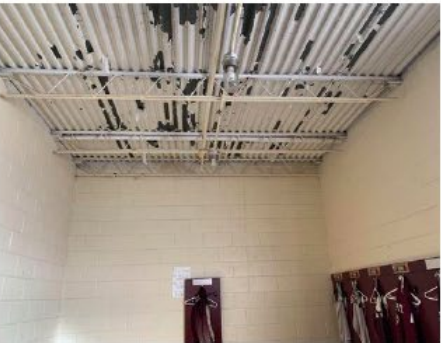
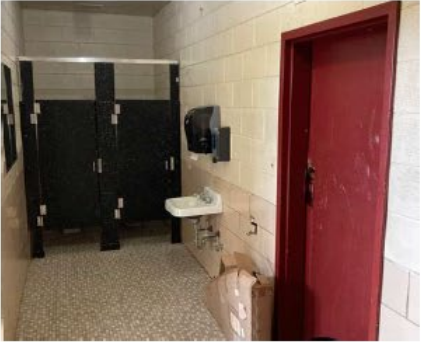
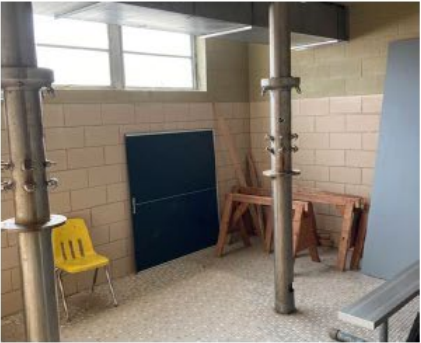
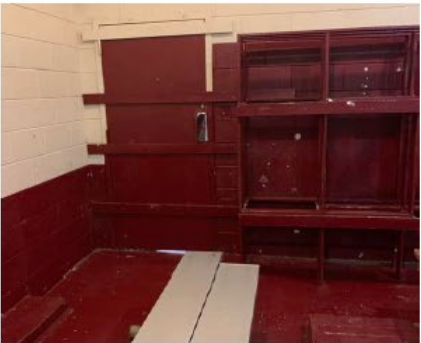
LOCKER ROOMS (BOYS)

The locker rooms for boys and girls and both in poor condition. There is a significant amount of mold and mildew apparent on the walls in the boys and girl's locker rooms. The paint is peeling off the underside of the decking in many of the spaces and needs to be addressed. The windows, lockers, tile floor, and plumbing fixtures will all need to be replaced within the space.

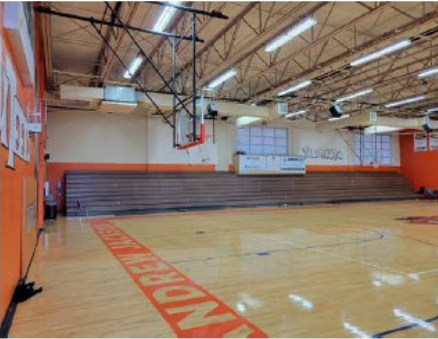
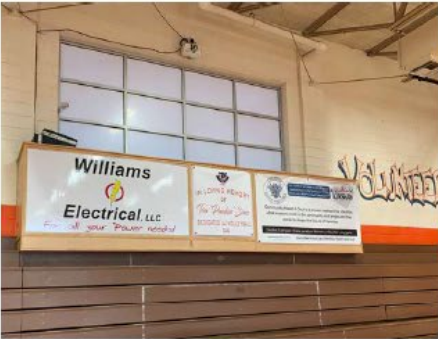
GYM

The lighting in the gym needs to be upgraded to LED lighting.

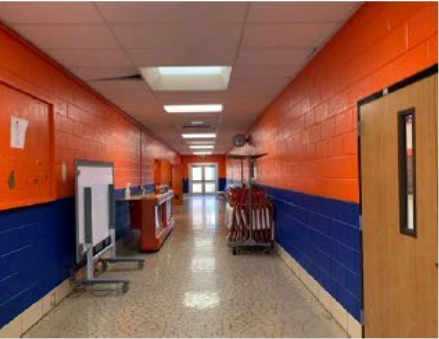
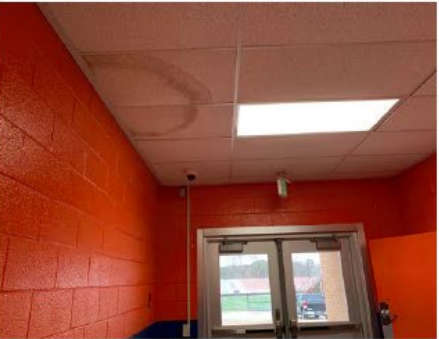
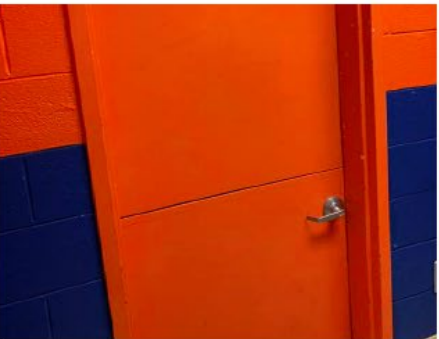
CORRIDOR

Several doors along the corridor have hardware that is not ADA compliant. They also show significant signs of wear and should be replaced. There is also signs of water damage on a few of the lay-in ceiling tiles and should be replaced

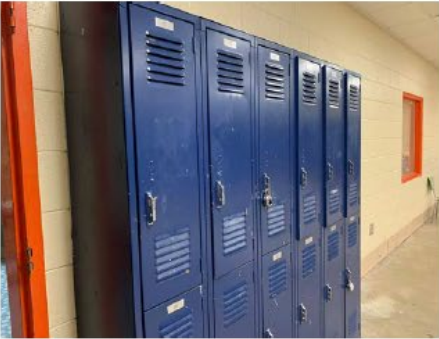
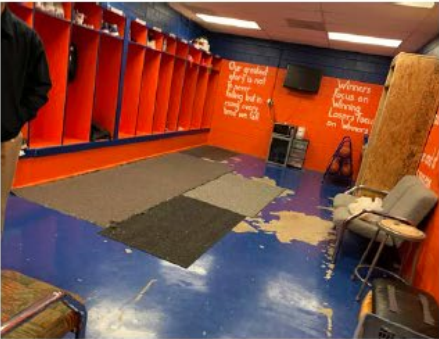
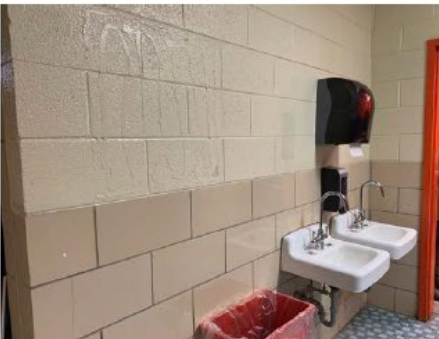
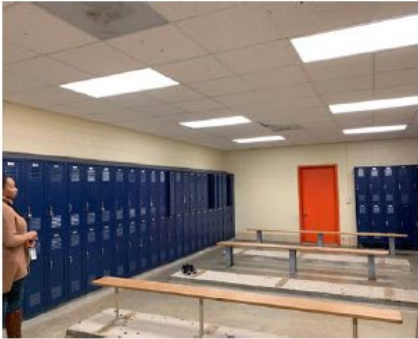
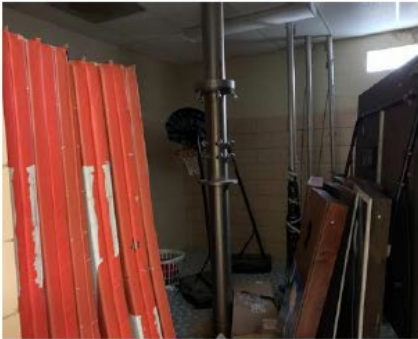
LOCKER ROOMS (BOYS)

The lay-in ceiling in the boy's locker room is damaged in certain locations and should be repaired. The tile in the both the boys and girls' locker rooms is in rough condition and should be replaced. While the partitions in the boy's restroom have been updated, the ones in the girls' locker rooms are dated/worn and should be updated. The painted concrete floor in the boys' basketball locker room is chipping and should be refreshed with a new coat of paint. The carpet in the girls' basketball locker room is significantly worn and will need to be replaced.

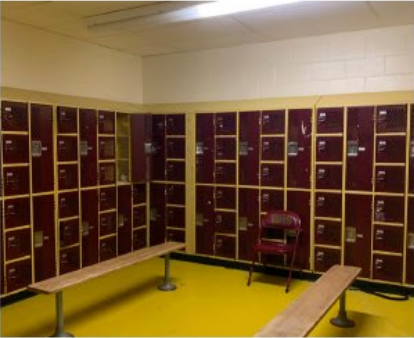
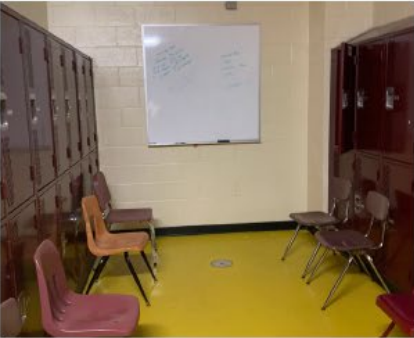
LOCKER ROOMS (BOYS)

The locker rooms are in good condition but would benefit from LED lighting and replacement of any damaged ceiling tiles. The CMU walls in the training room are peeling in several locations along the tile wall base and should be repainted. The casework in this location is dated but still in good condition.
